American Roofing Slate

History

Types of Slate

Fabrication

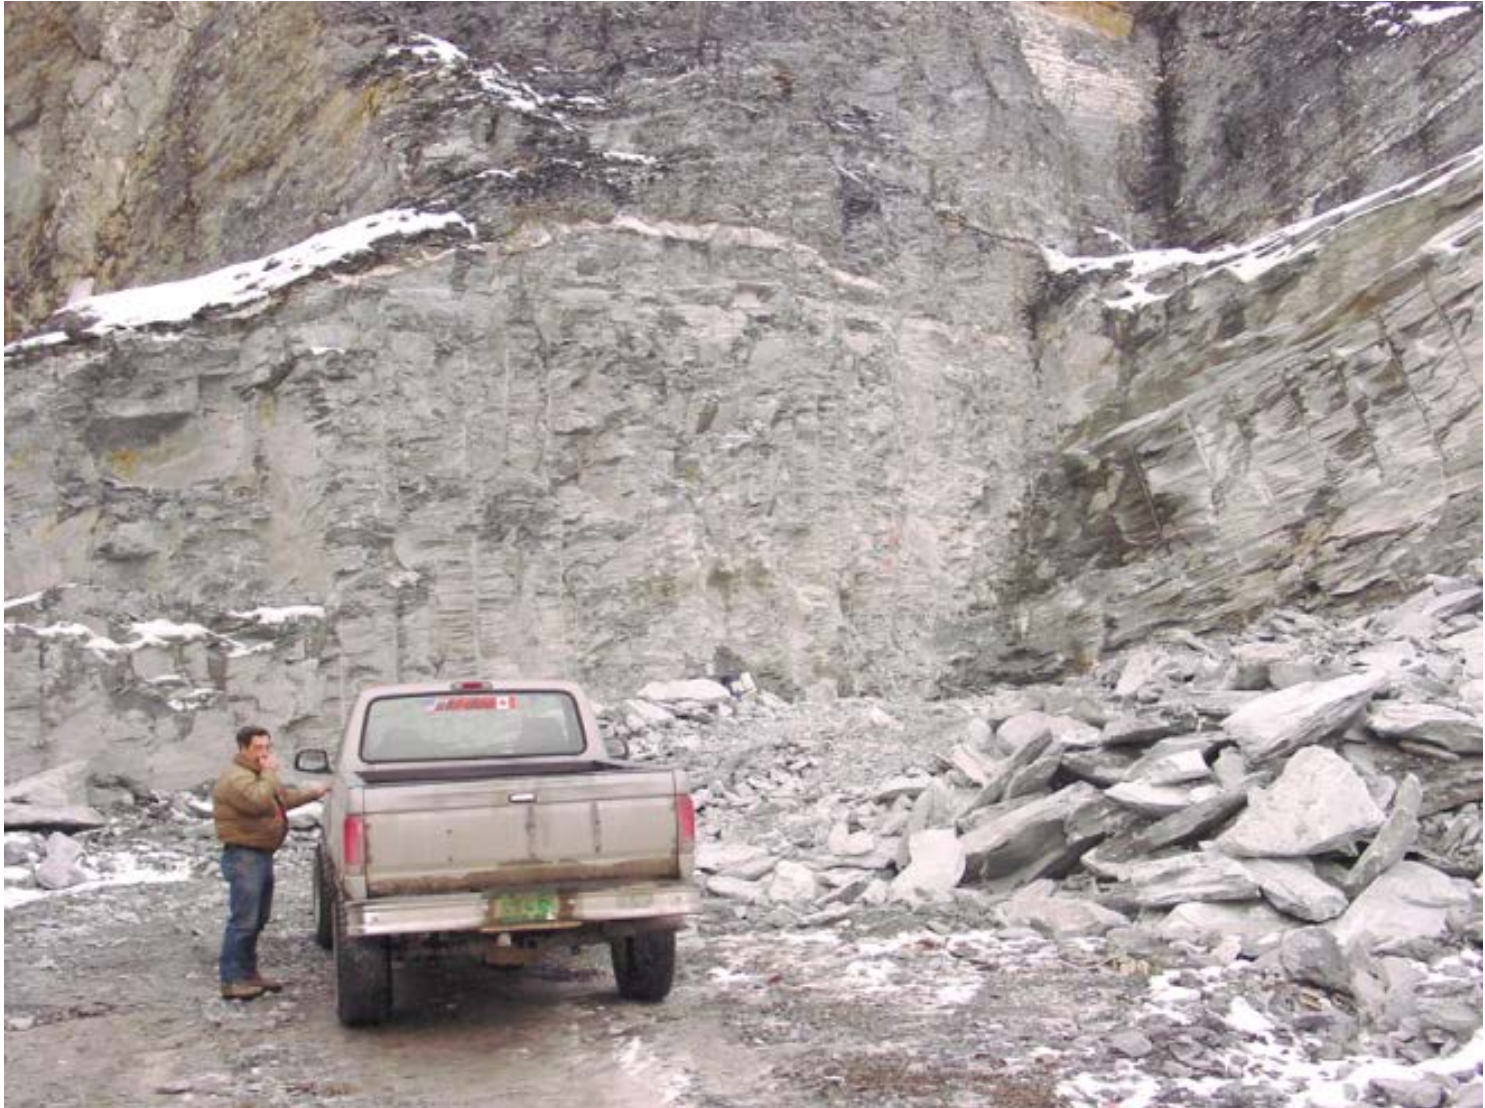
This is a quarry at Camara Slate Co., Vermont. Most slate in the U.S. is now quarried from open holes.

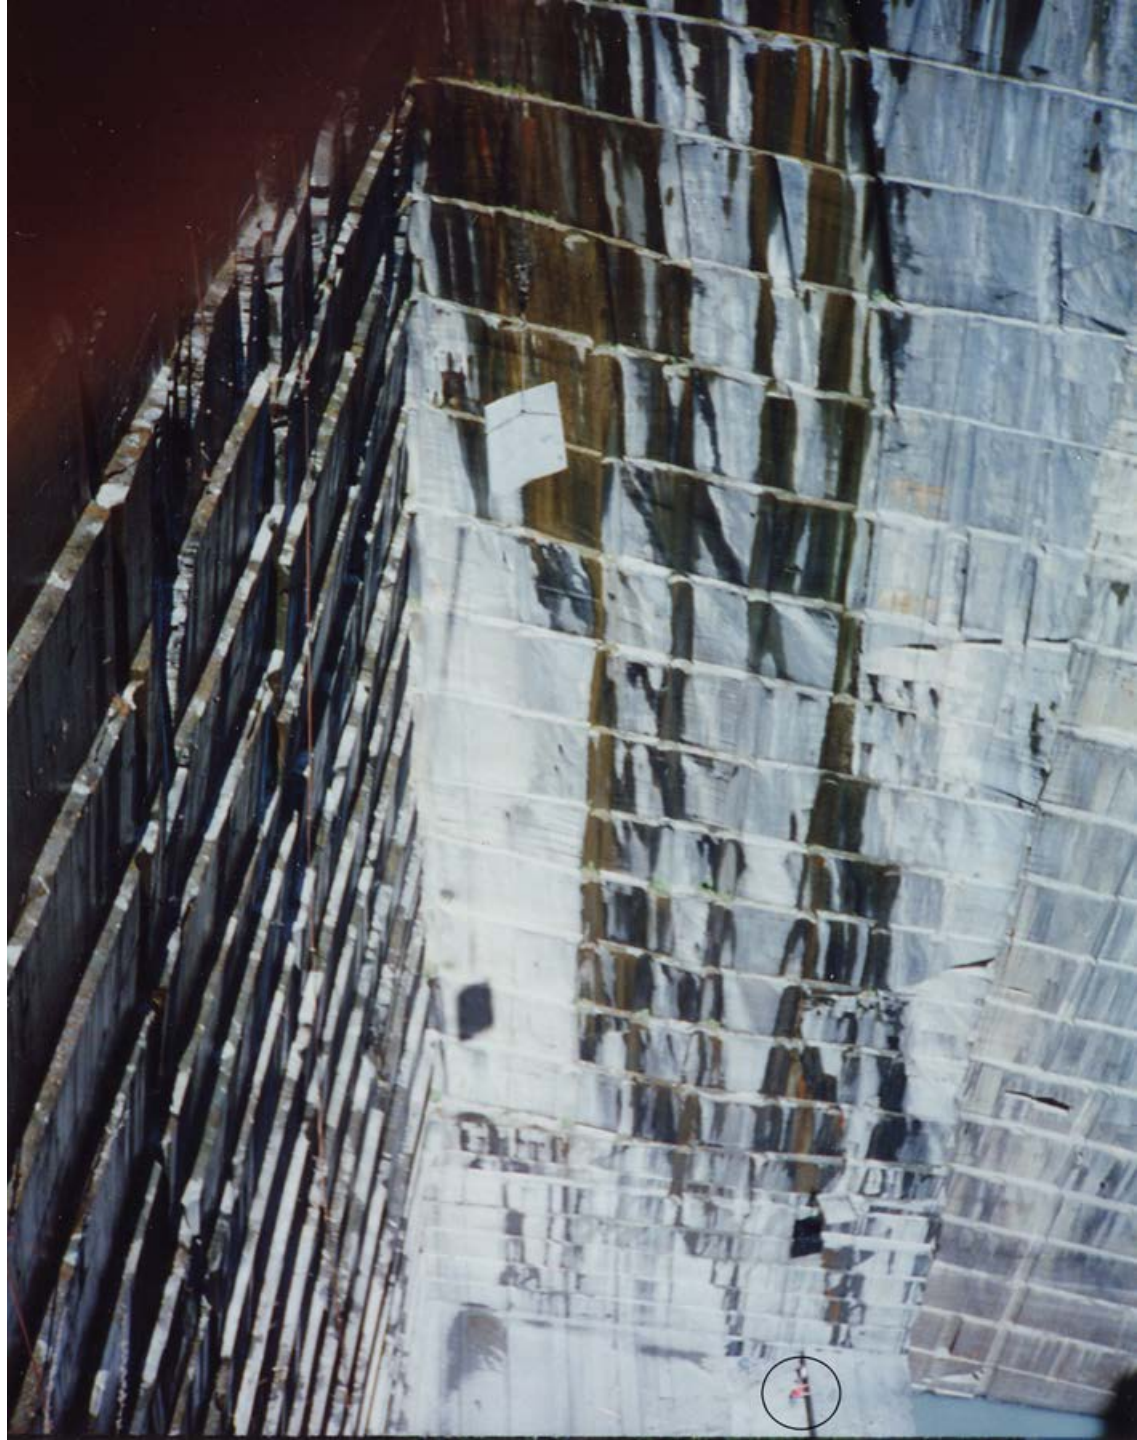
A Pennsylvania quarry is carved into solid slate rock. A worker is circled at the bottom, right. A block is being hoisted out of the quarry on a chain. The hole is about 350' deep (107 meters).

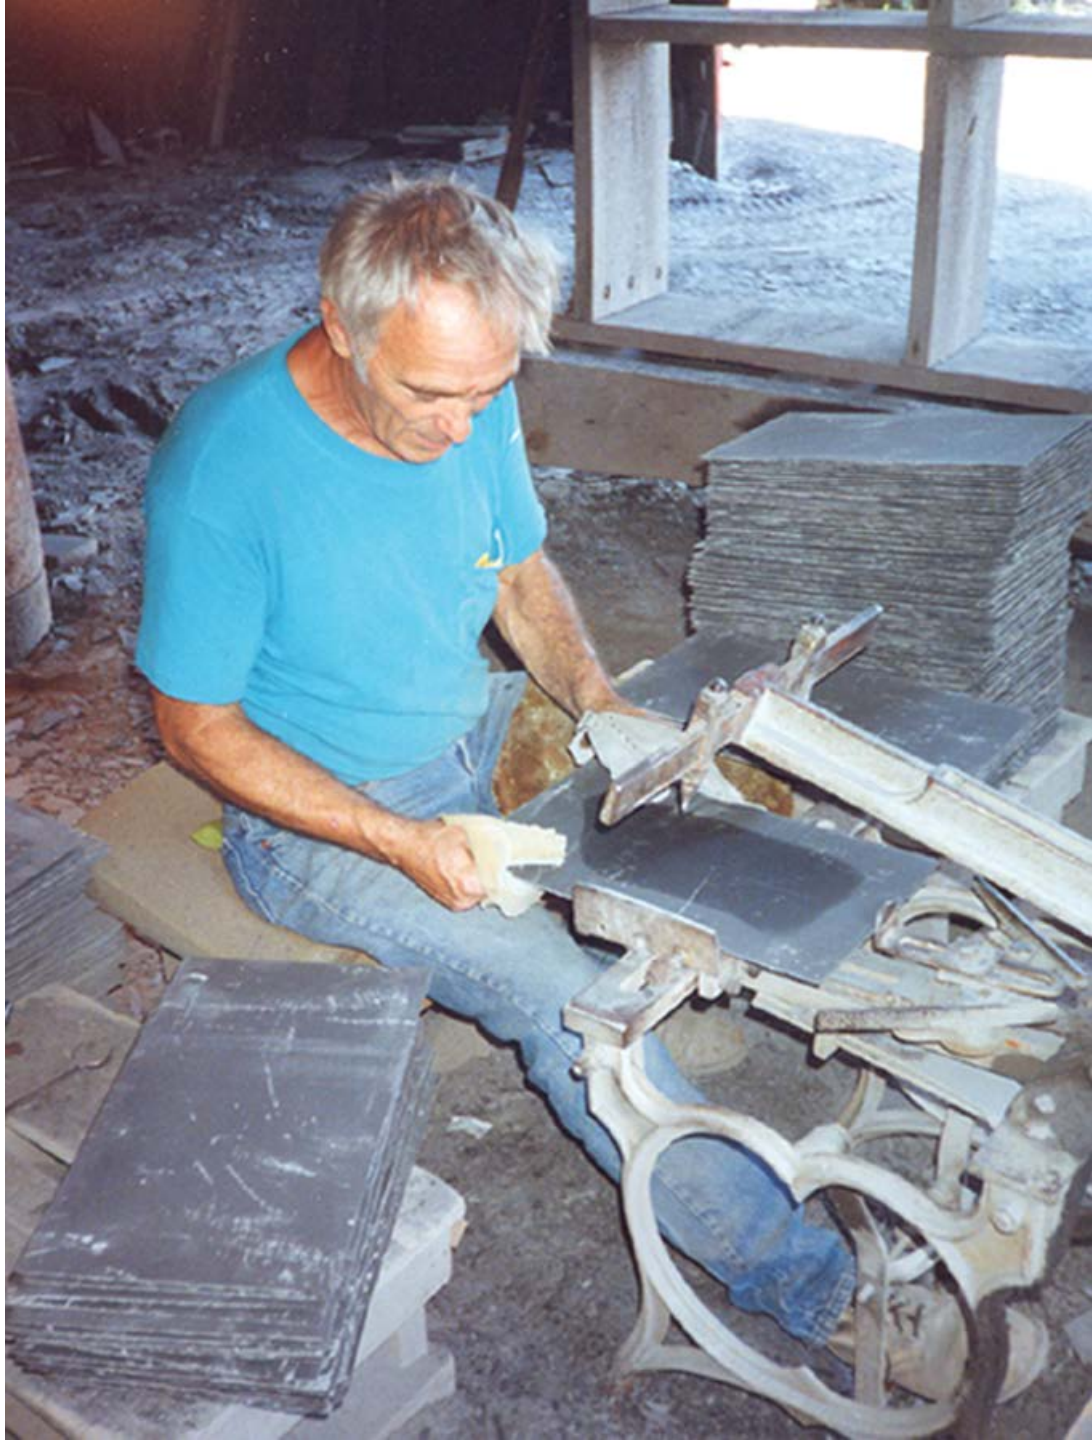
Nail holes are then punched into the slates individually. Some quarries drill nail holes, but punched holes are much preferred by professional slaters. Roof slates are not sold without nail holes.

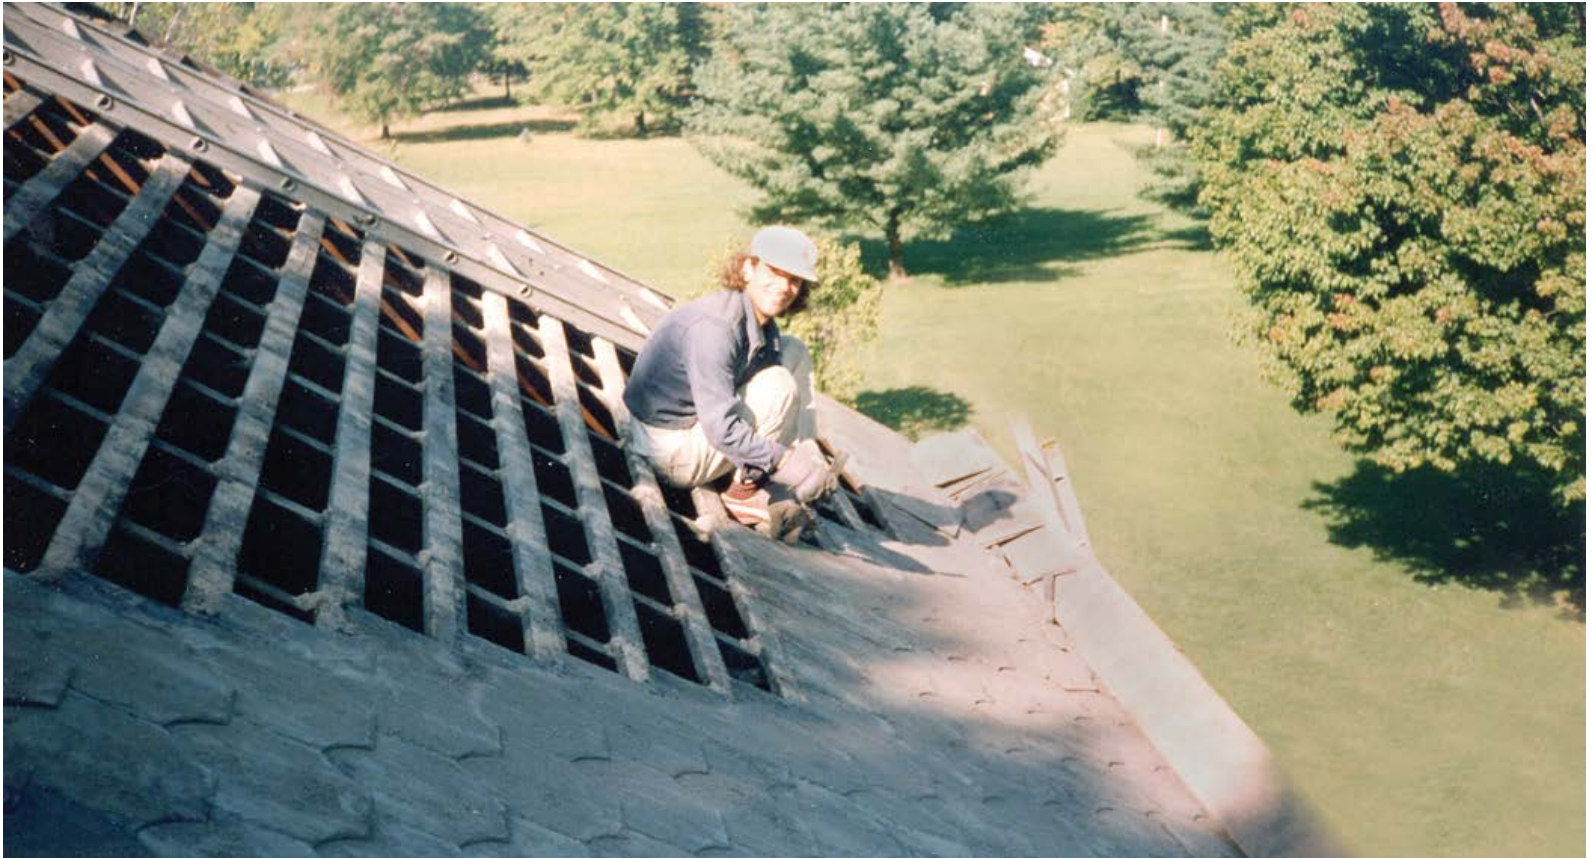
This lath roof is 100 years old. No underlayment (felt paper) was used. The slate is still good – the roof did not leak.

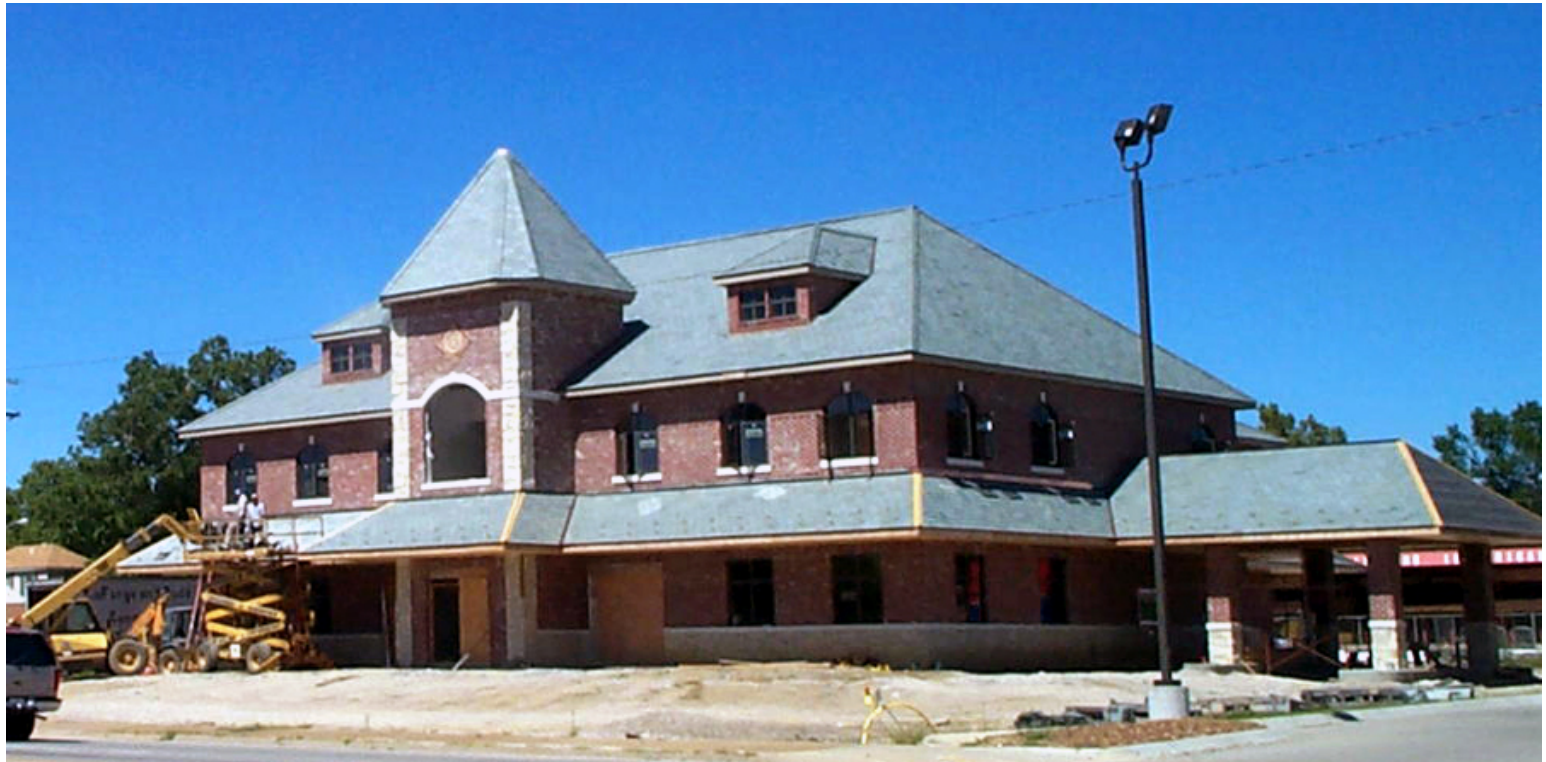
New Vermont unfading green slate, 1.25 cm thick, installed on yellow pine decking with stainless steel nails. This roof should last 200 years.

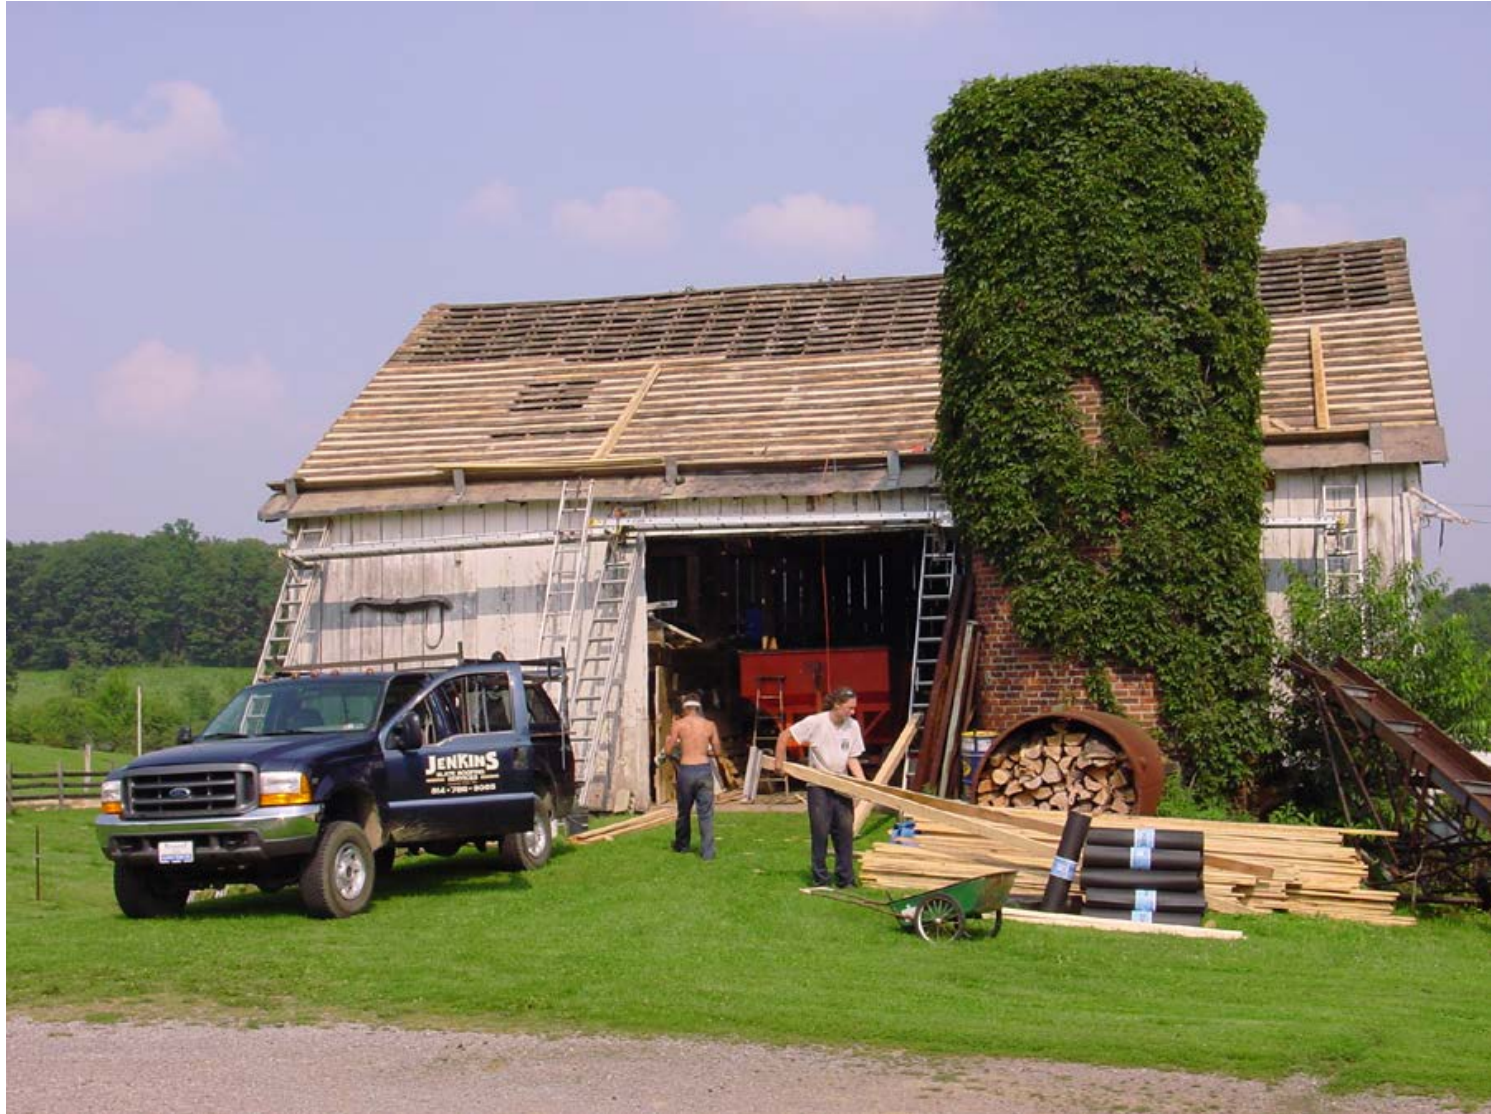
A lath barn being reslated by adding 1x4s between the lath.

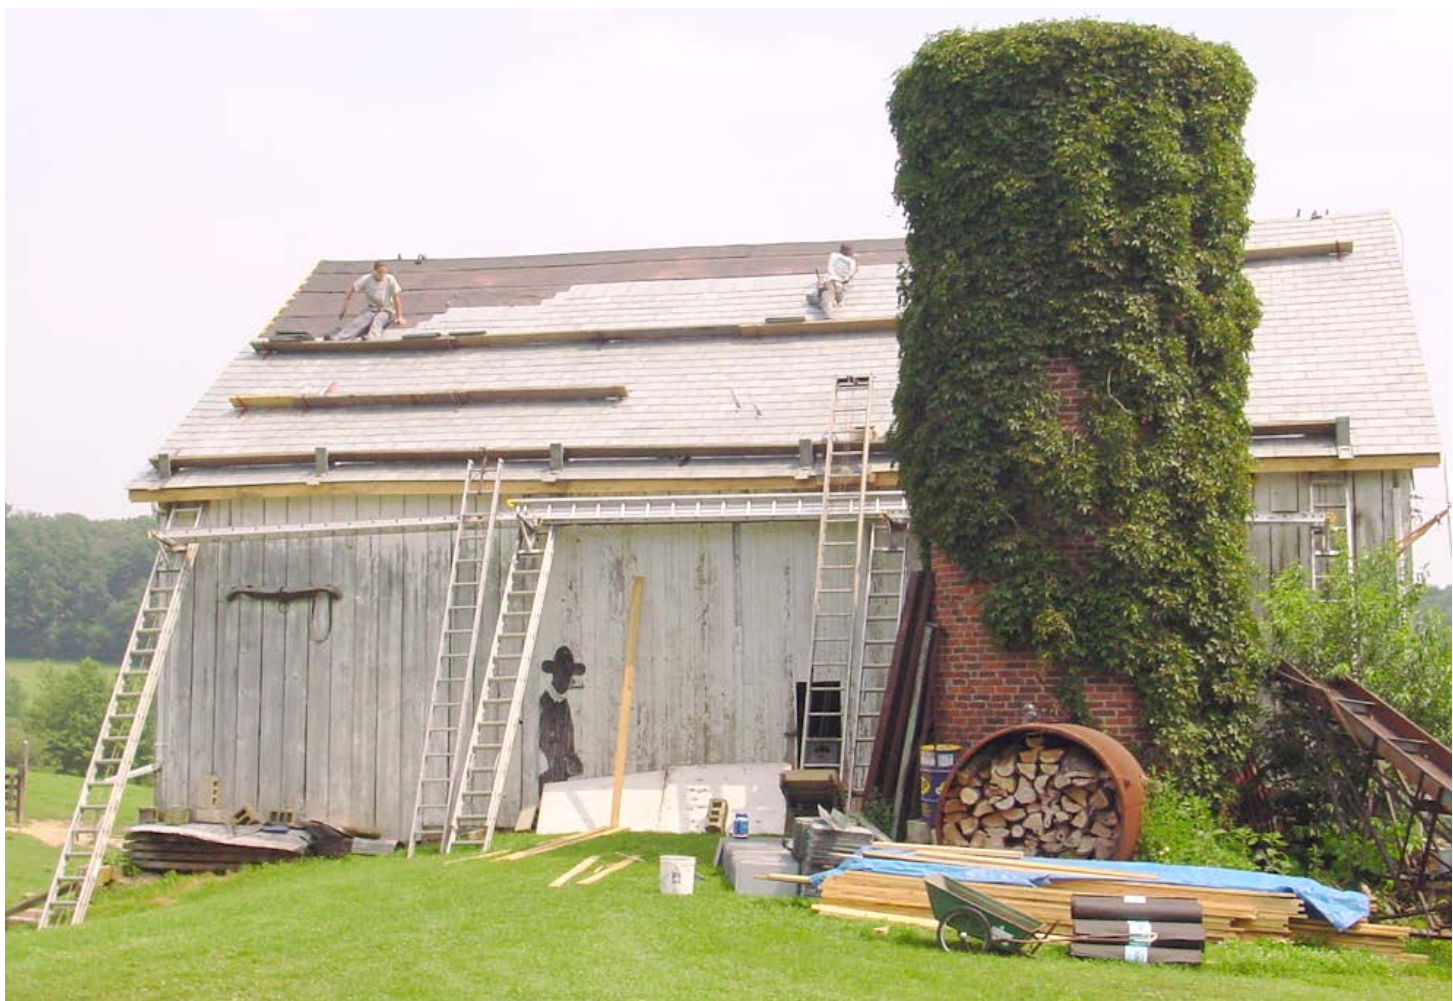
The slate is installed directly over the felt by nailing each piece with two nails, usually 1.5" (3.8 cm) long.

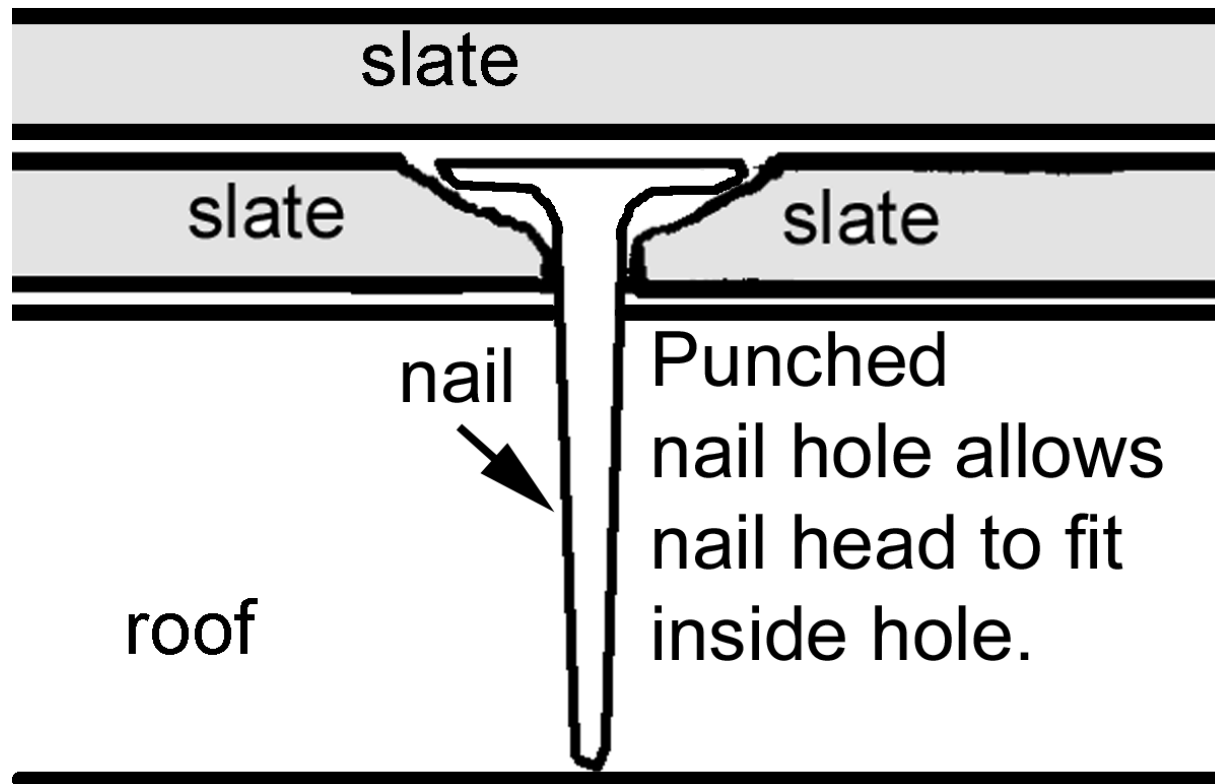
Nail holes should be punched, not drilled, except on thick slates, where drilling may be necessary.

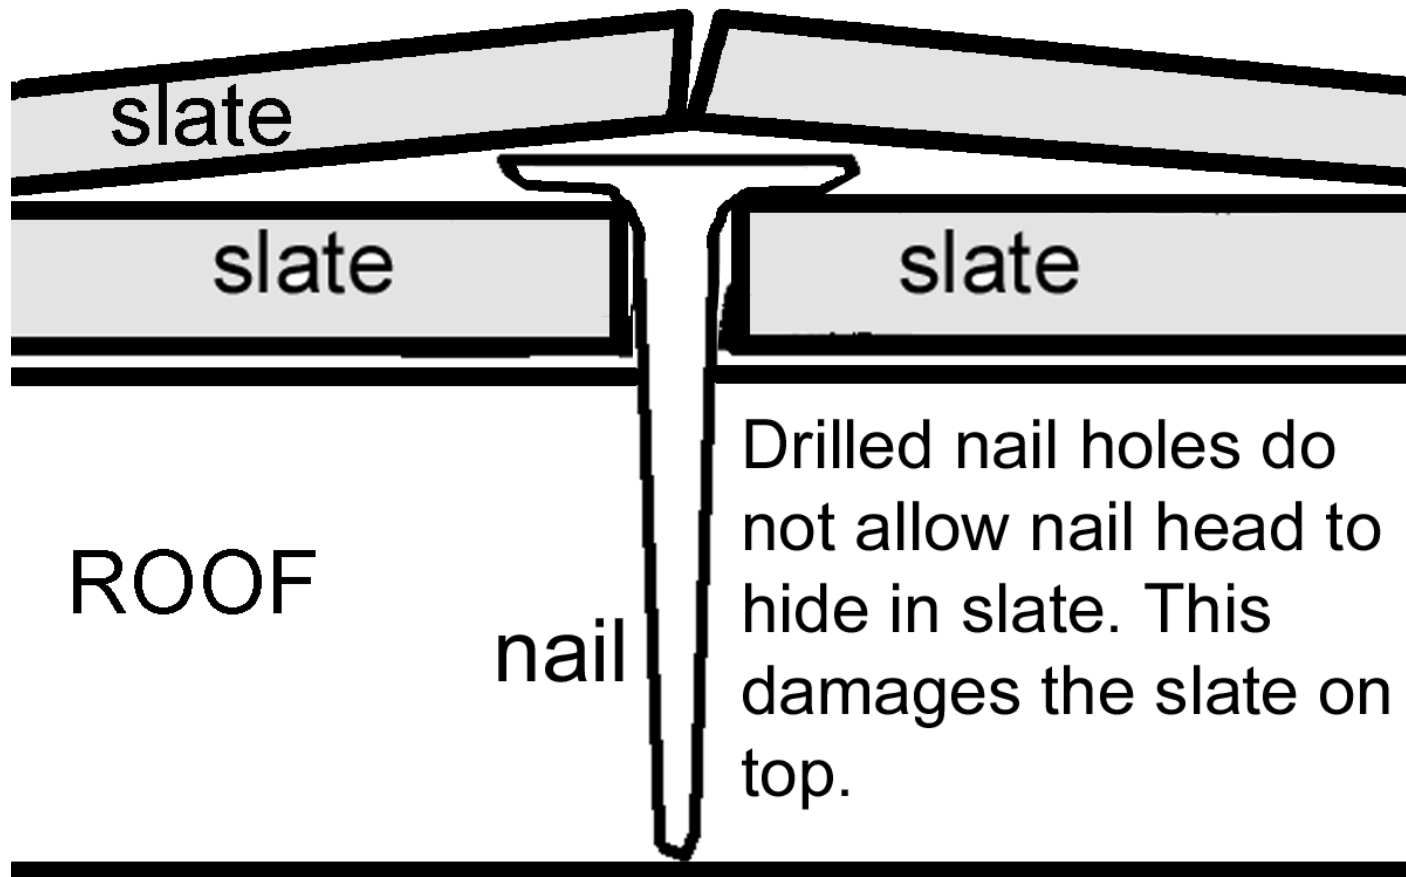
Drilled holes cause the nail head to stick up and rub against the overlying slate.

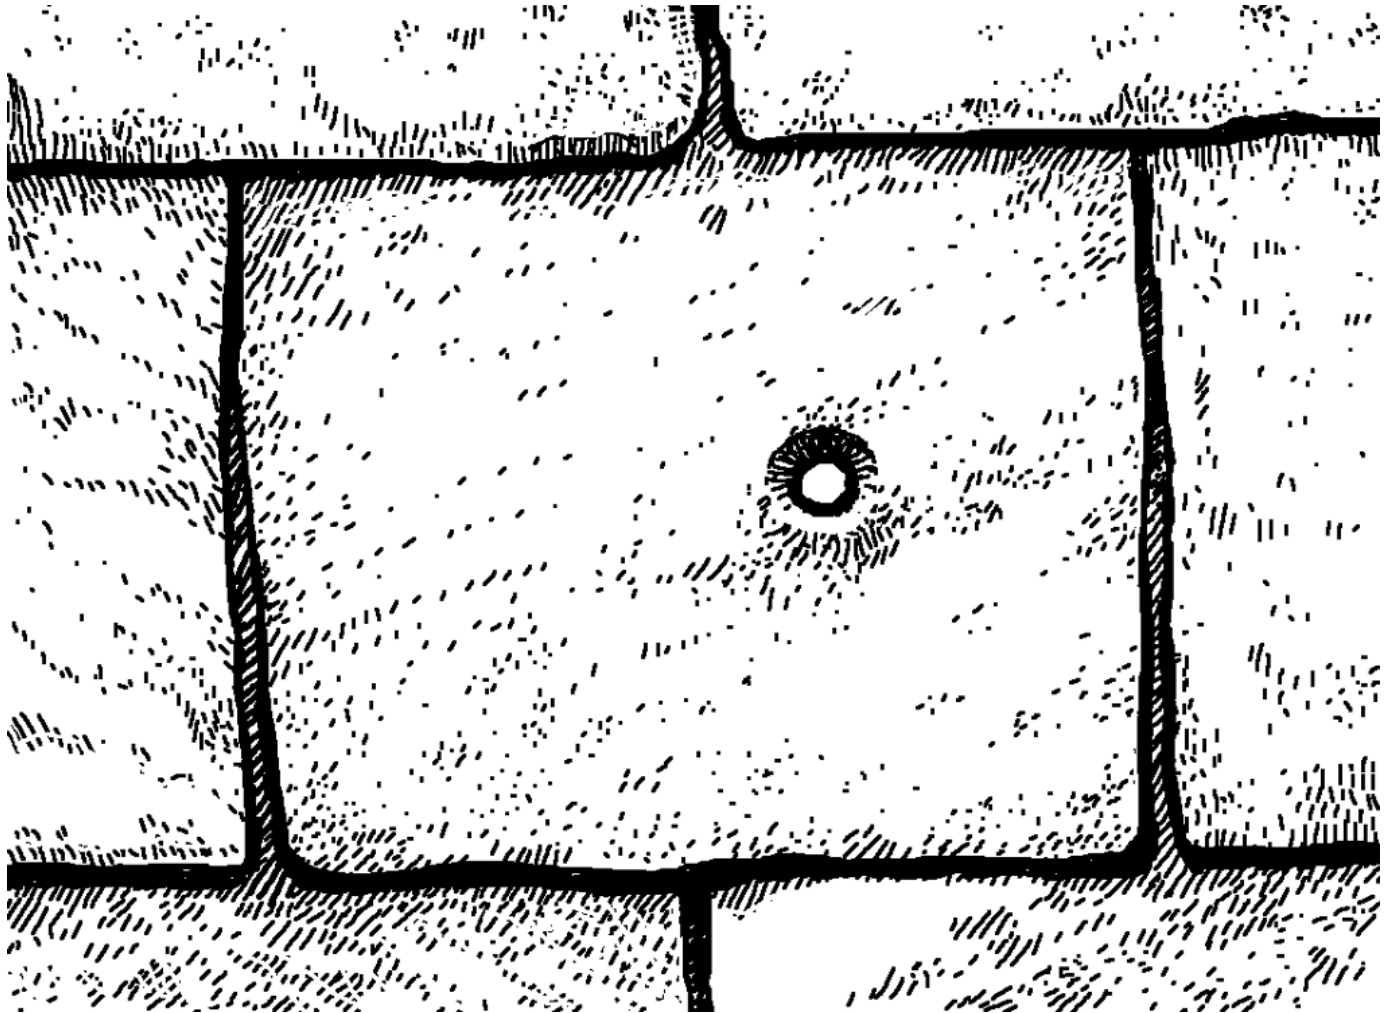
The nail head will wear a hole in the roof over time.

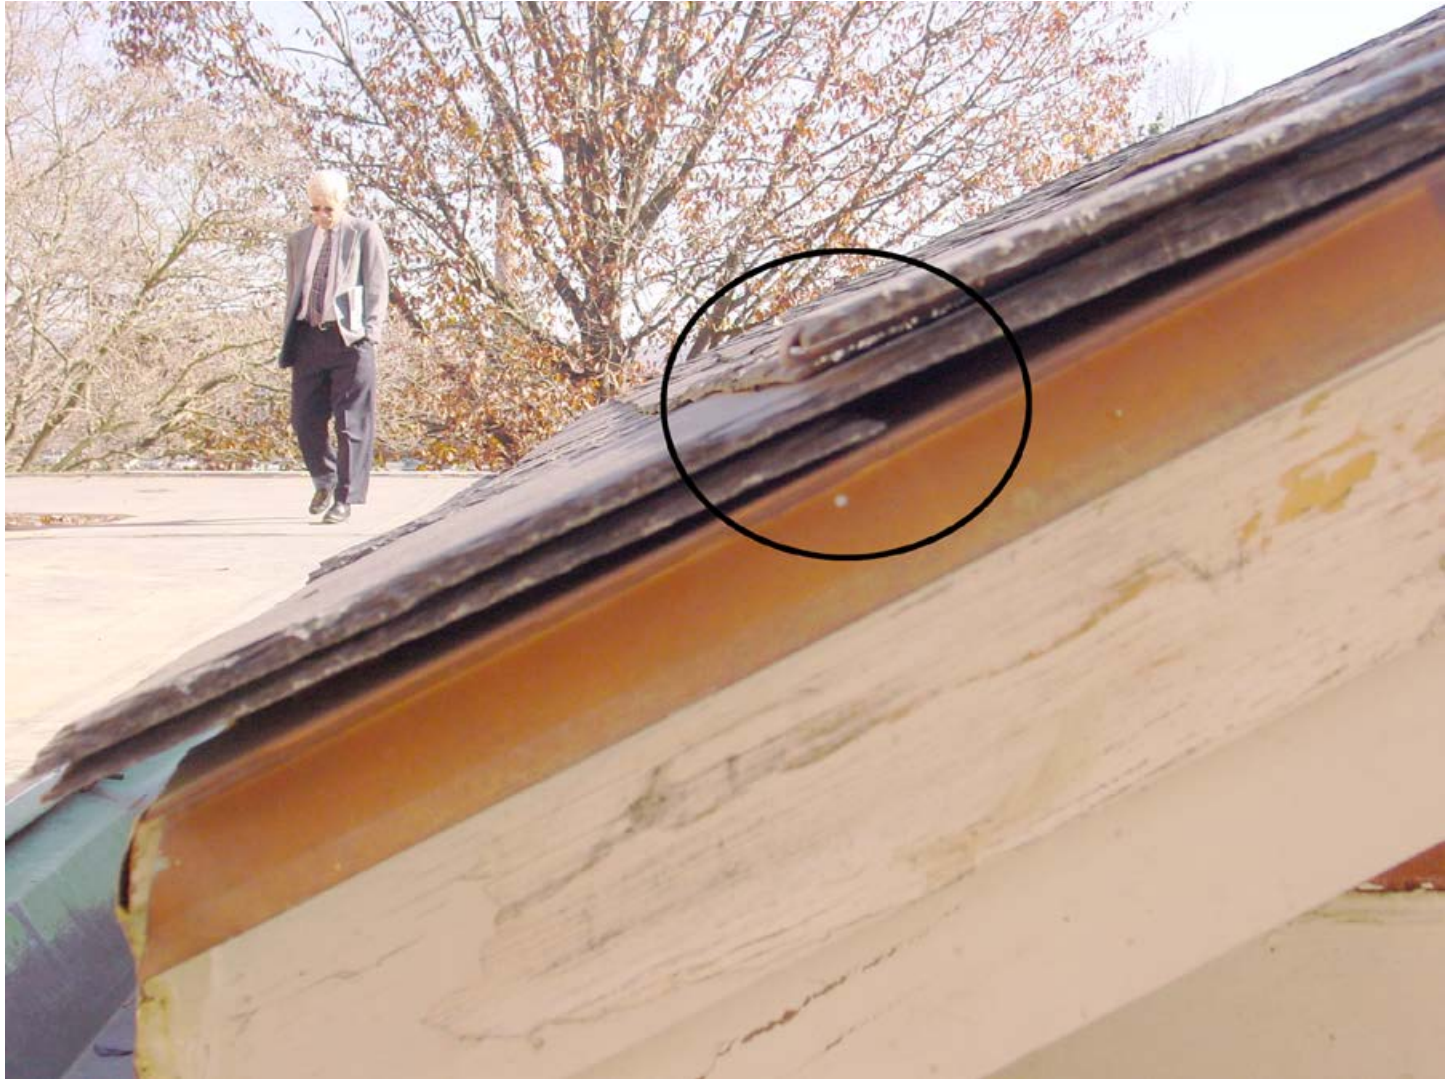
But training is lacking and many roofs are being installed incorrectly, such as this same dorm roof, made of Chinese slate. Note the lack of headlap.

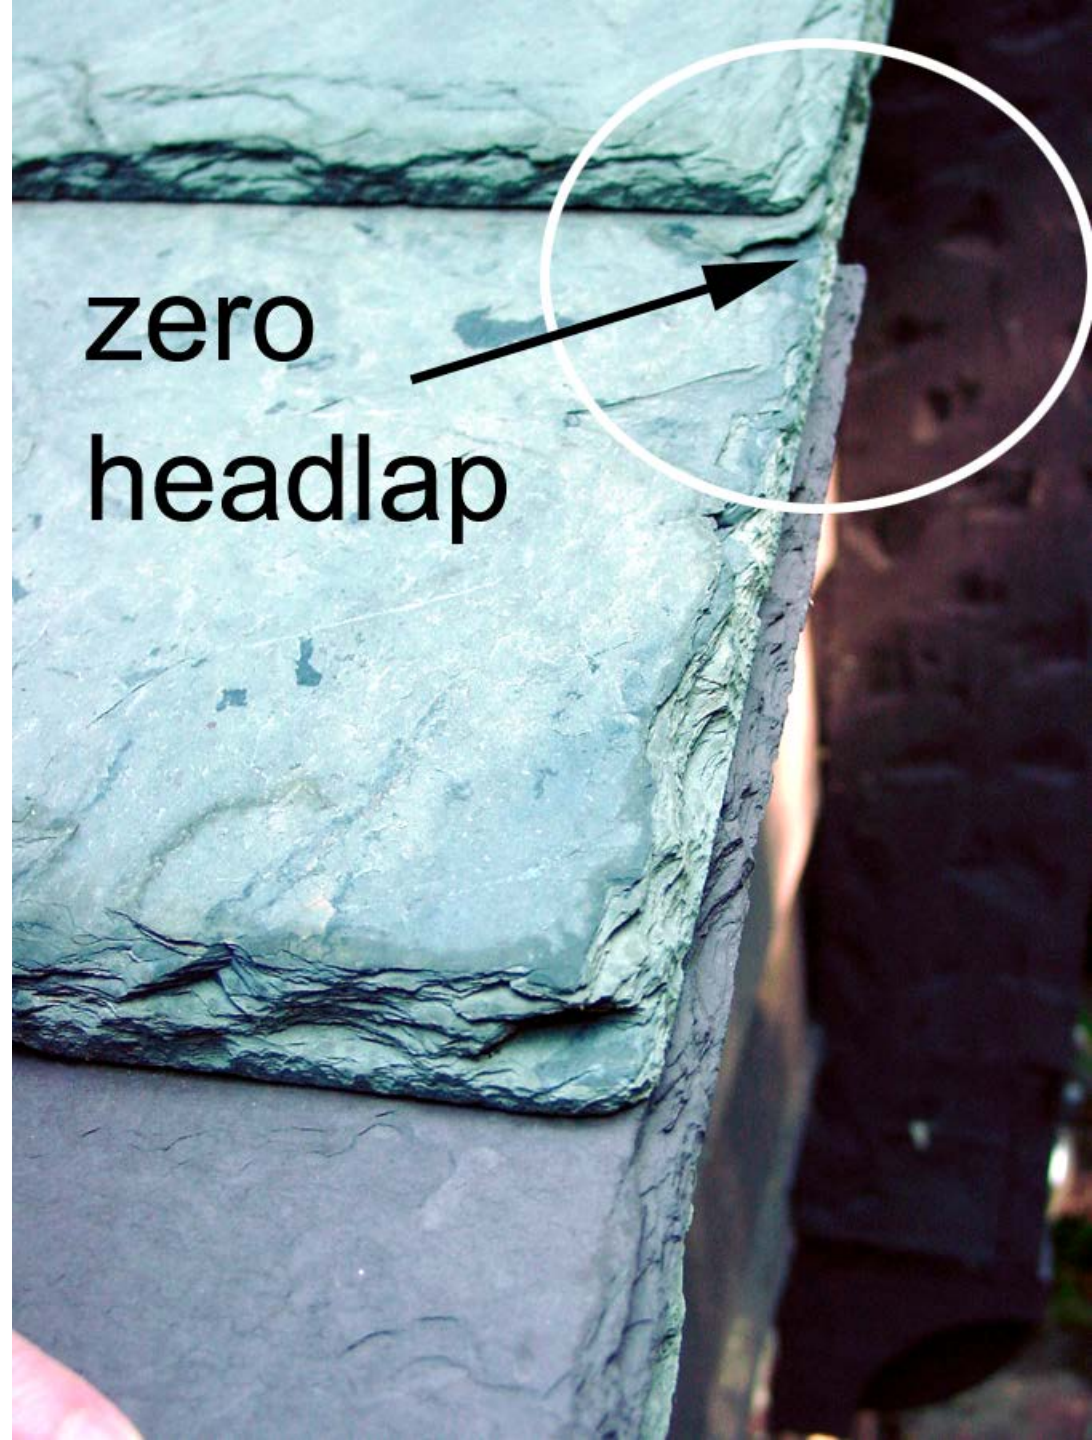
Another case of zero headlap -- on an historic building. The entire roof was installed incorrectly and had to be removed.

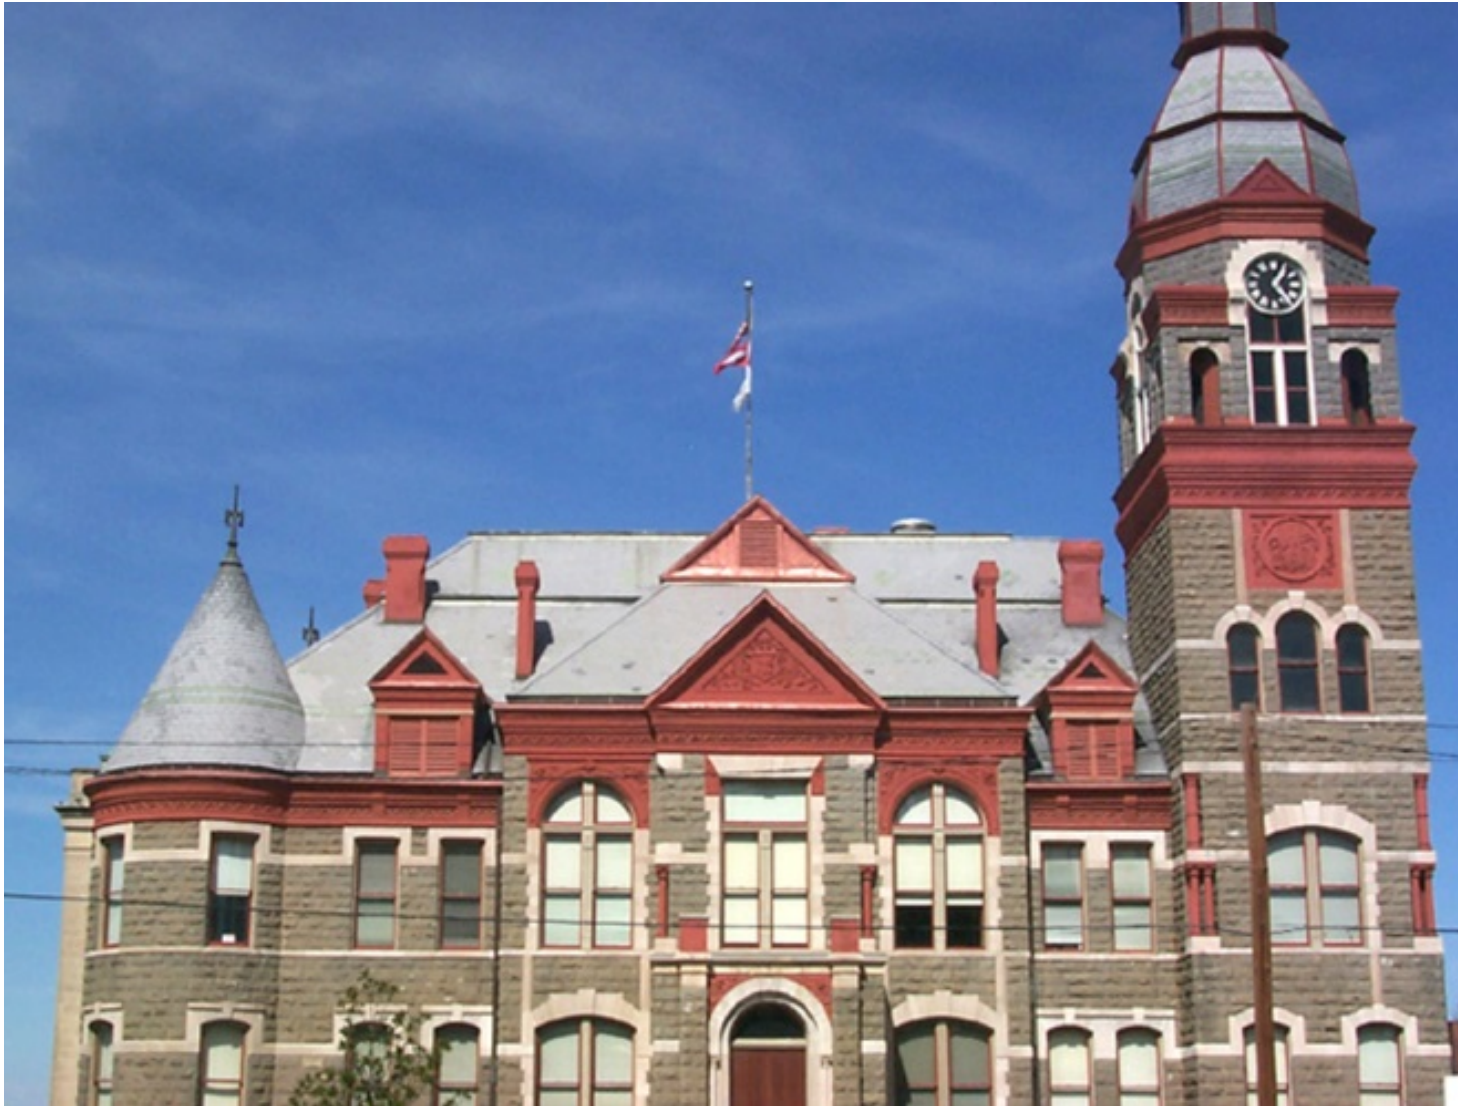
“Fake” slates are becoming more popular. This fake slate roof is 10 years old and already has to be completely replaced.
We discourage the use of such materials.

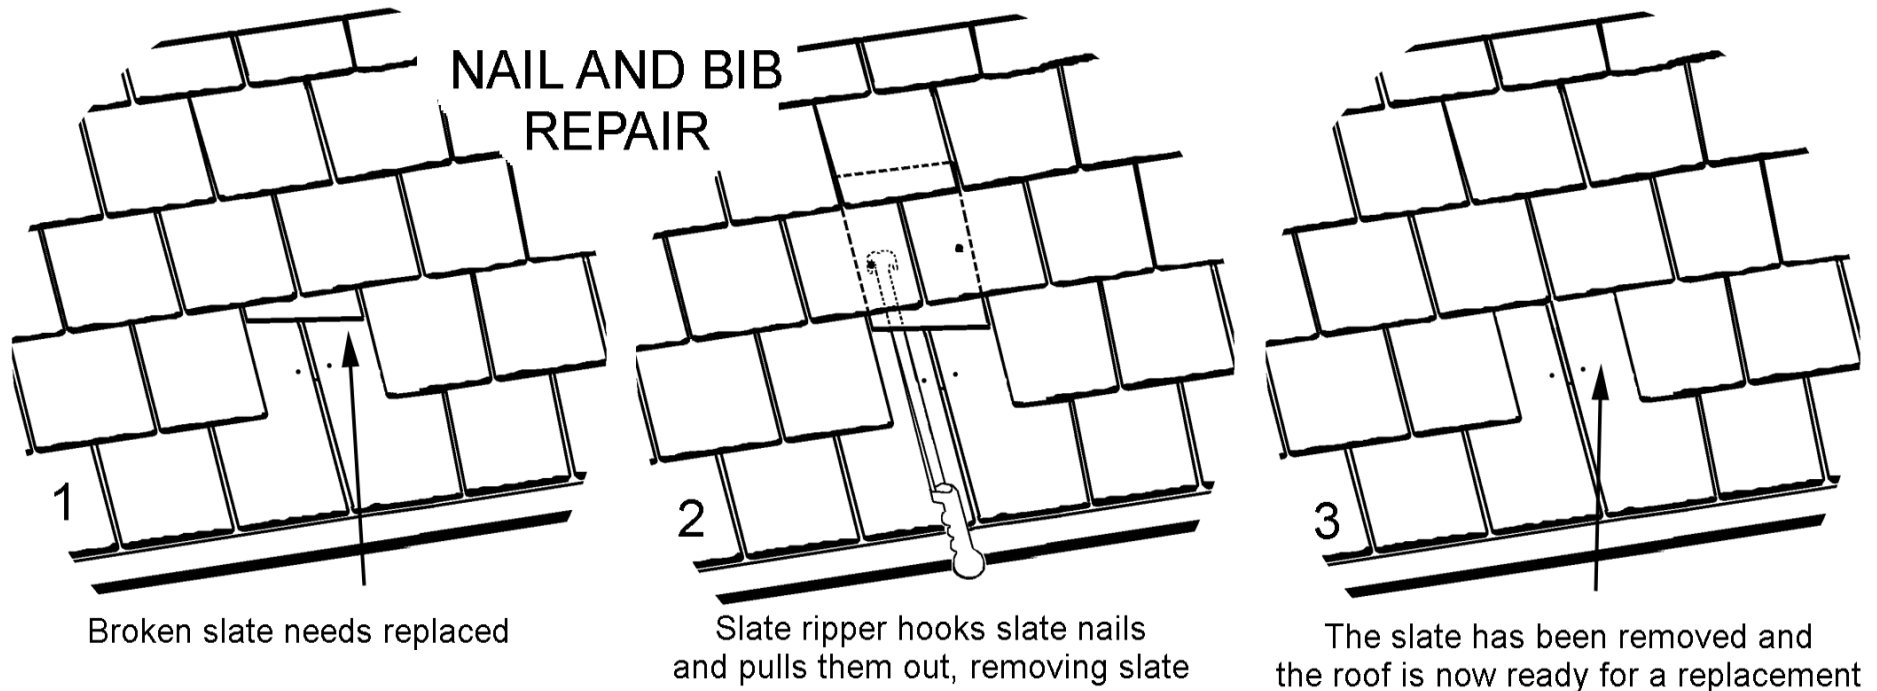
Any individual slate can be removed from the roof and replaced. The slate is pulled out using a “slate ripper,” then replaced using a nail and “bib” flashing.

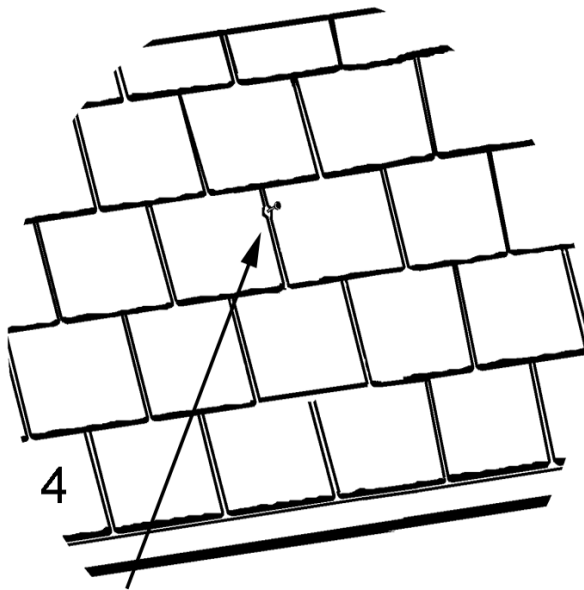
Replacement slate is slid into place and fastened with a nail in the slot

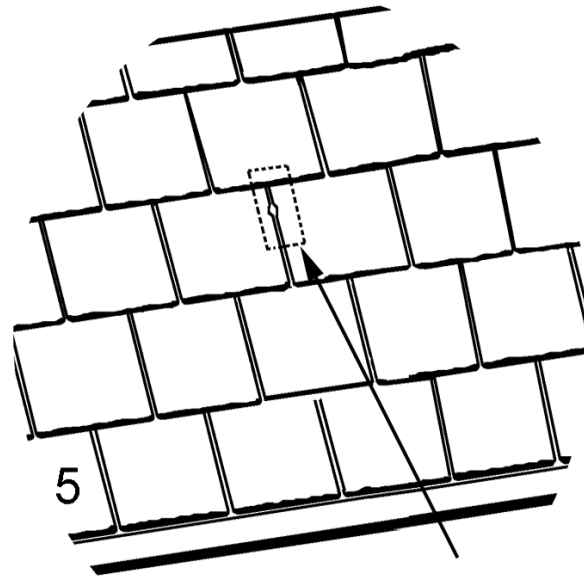
The roofing nail is tapped down and a bib flashing is slid under the slate but over the nail head

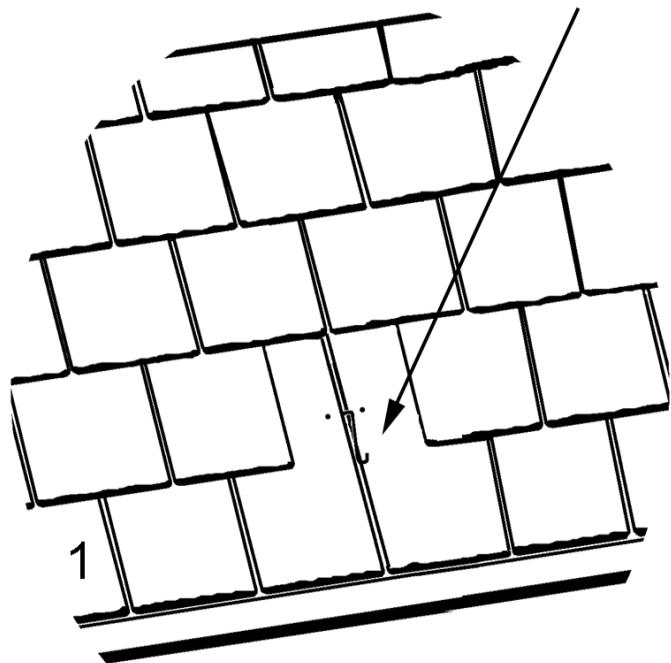
Alternatively, a copper or stainless steel slate hook can be nailed into place after the old broken slate has been removed

The replacement slate is then slid in place where it is permanently held by the slate hook. The hook can be pushed down between the underlying slates, if needed, in order to make more room for sliding the slate in place.

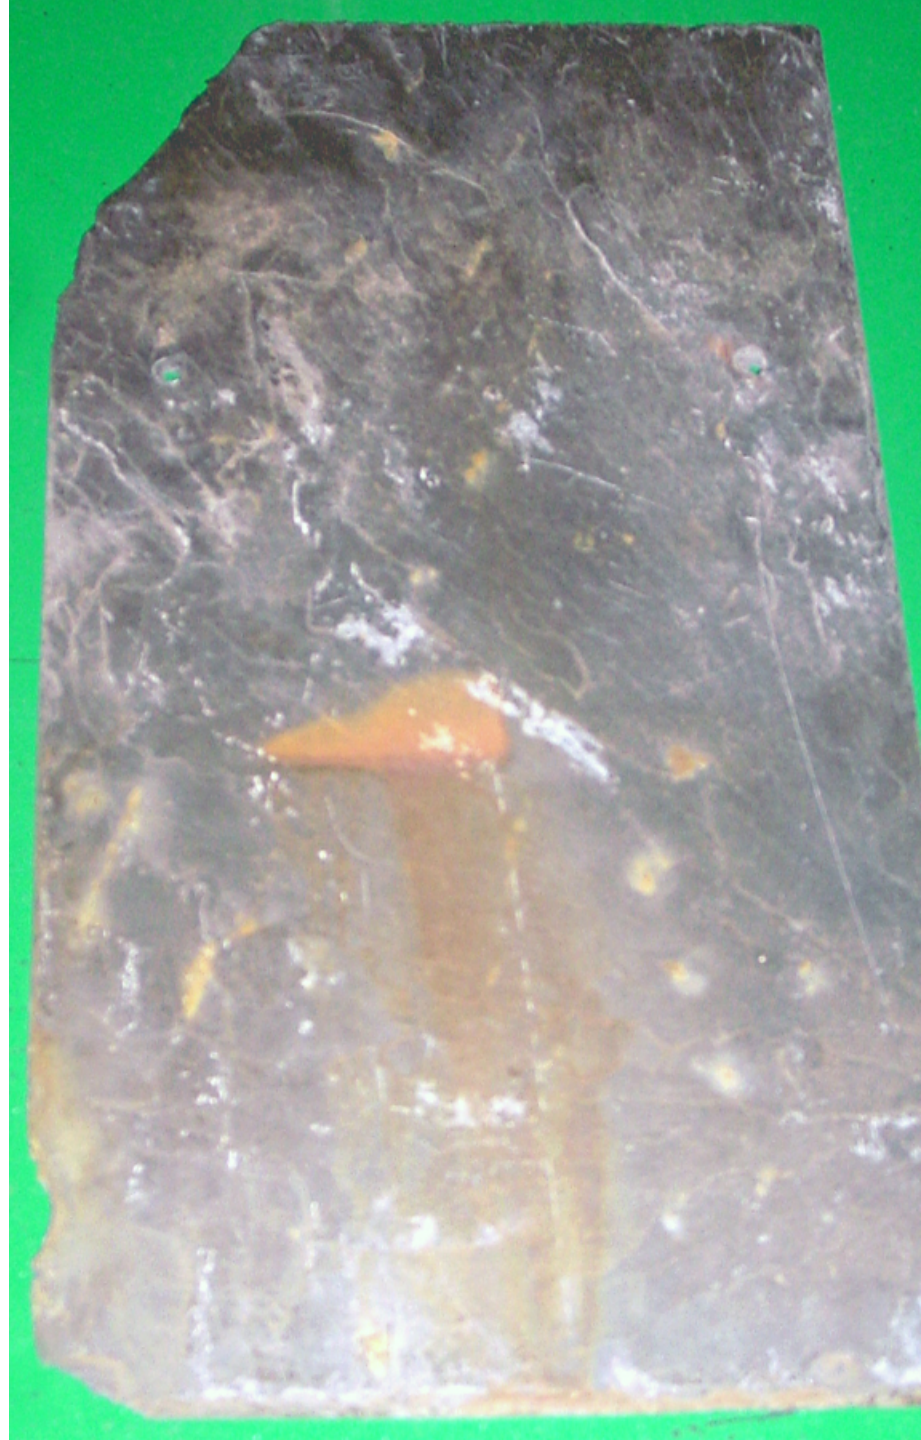
This Spanish slate bled rust stains all over a new \$130,000 slate roof. The entire roof had to be replaced.
